**GRAPHIC 4 Sand Slurry Removal-Crane with Eductor-Alternative B, Option 2.**

**GRAPHIC 8 Slurry Extraction Schematic**

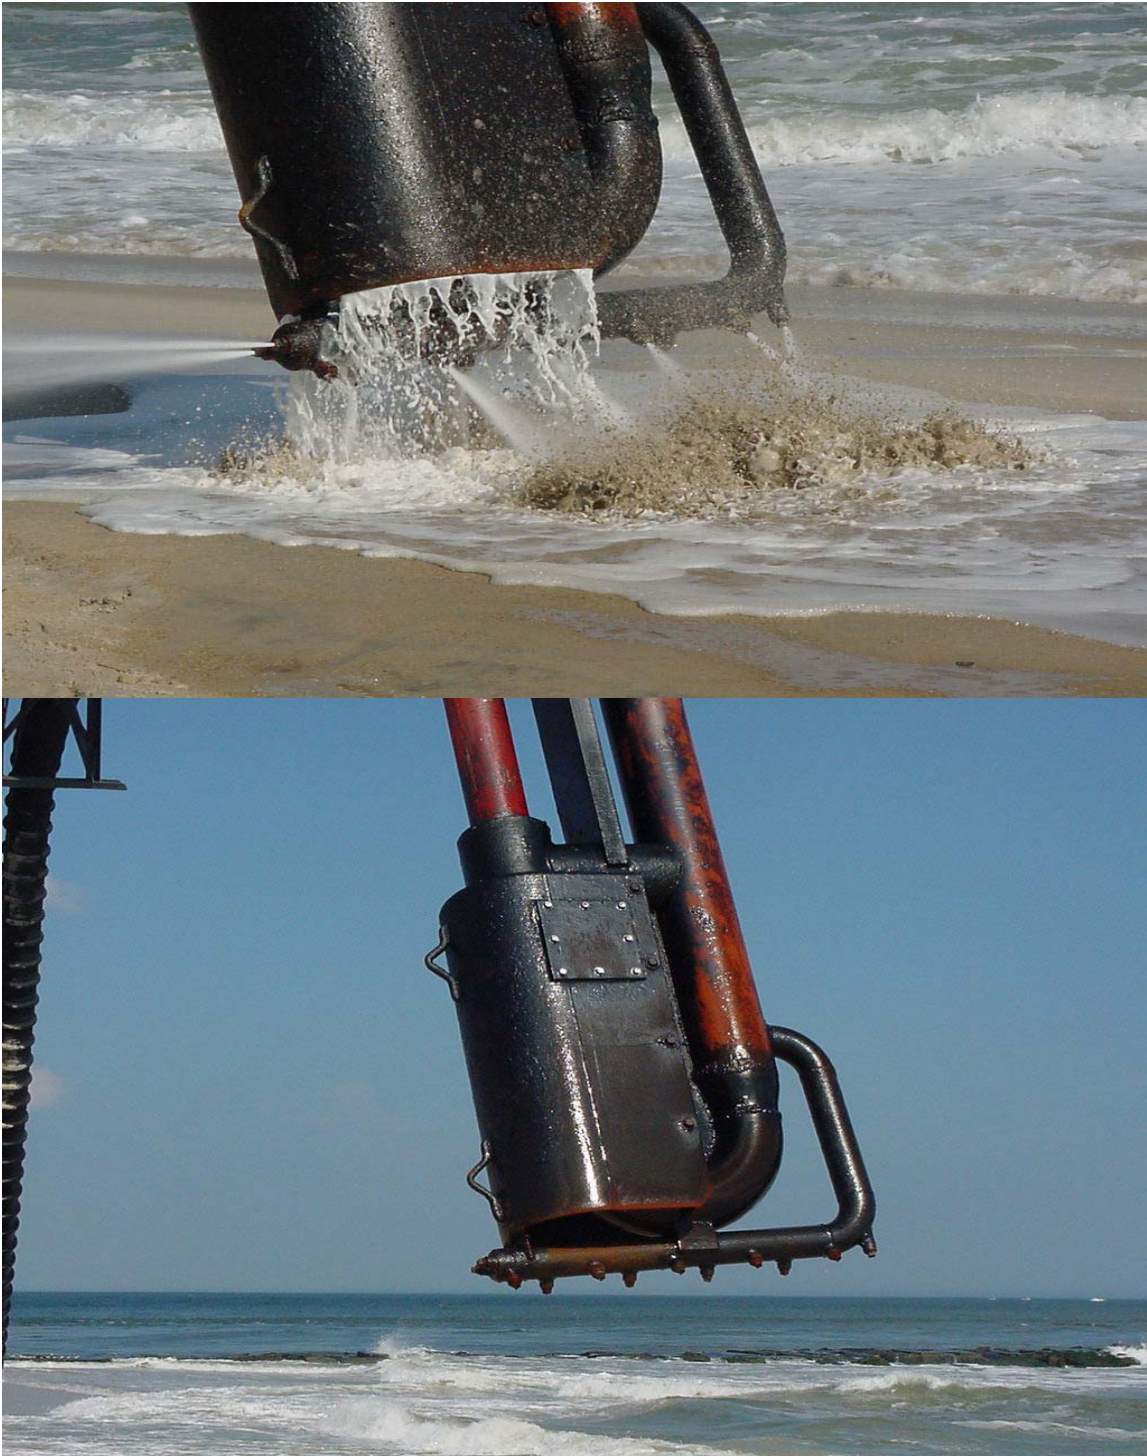
**GRAPHIC 5 Eductor Assembly Unit**

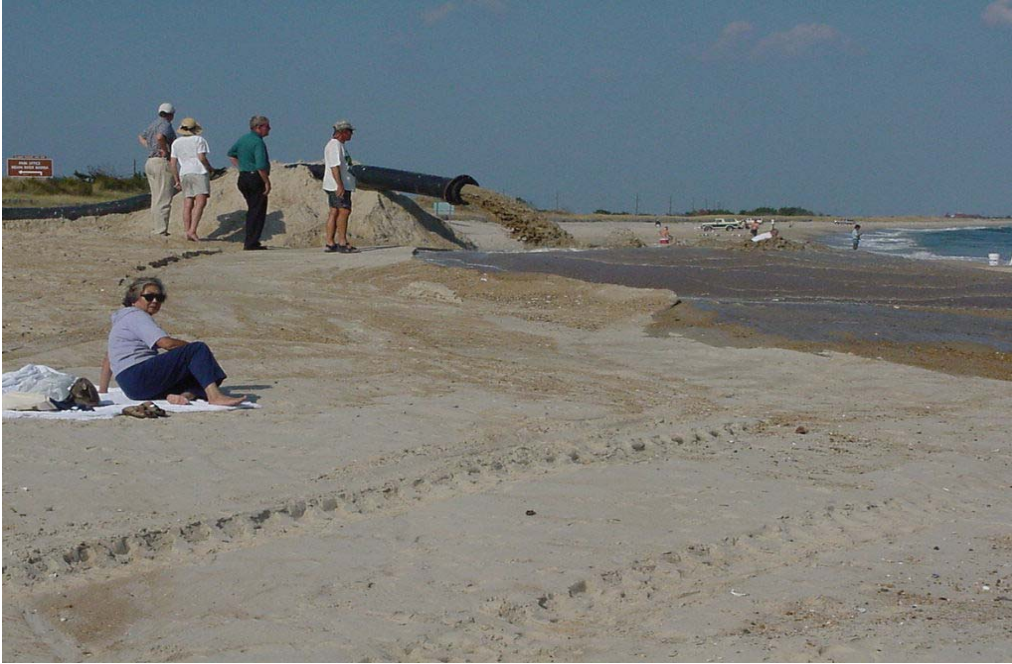
**GRAPHIC 6 Sand Slurry Pipeline Deposition**

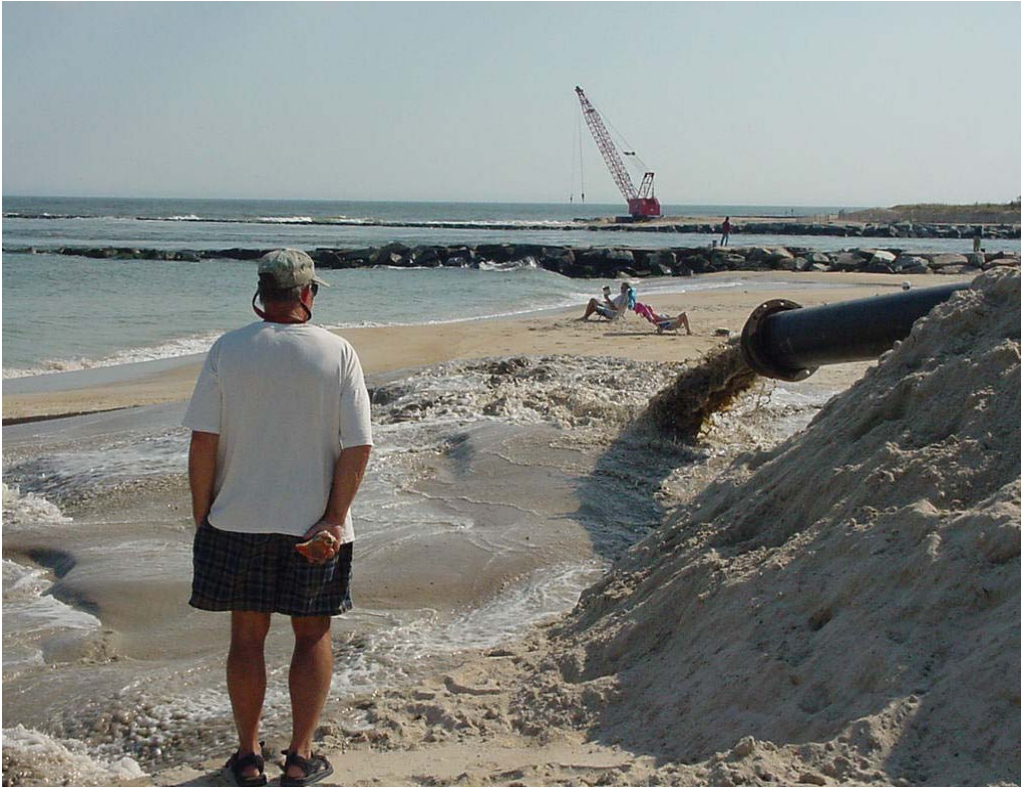
**GRAPHIC 7 Sand Slurry Pipeline Deposition**

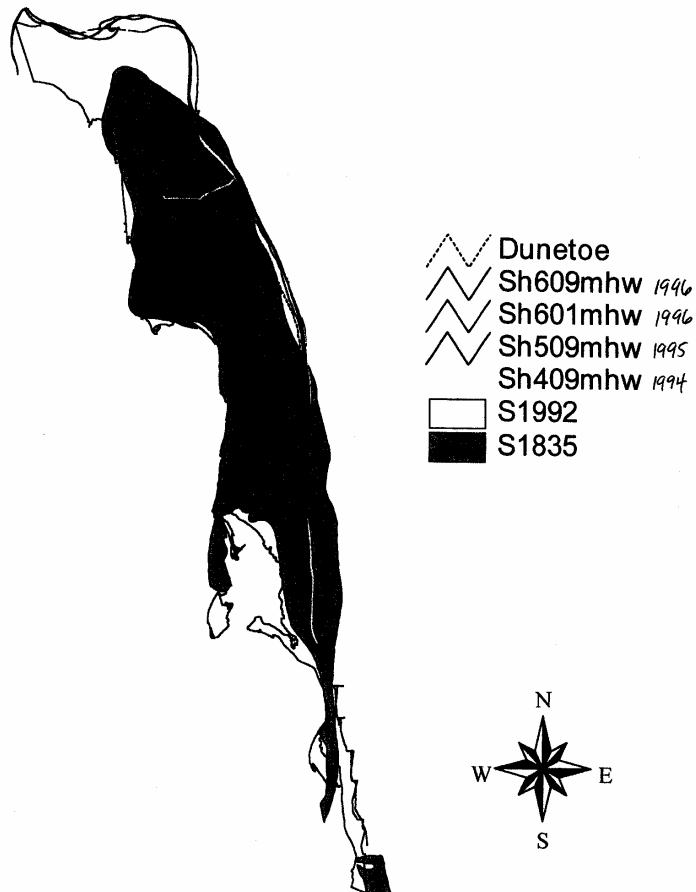
GRAPHIC 9 Historical Shoreline

Figure 2. Sandy Hook Historical Shoreline

## Sandy Hook, 1835-1996

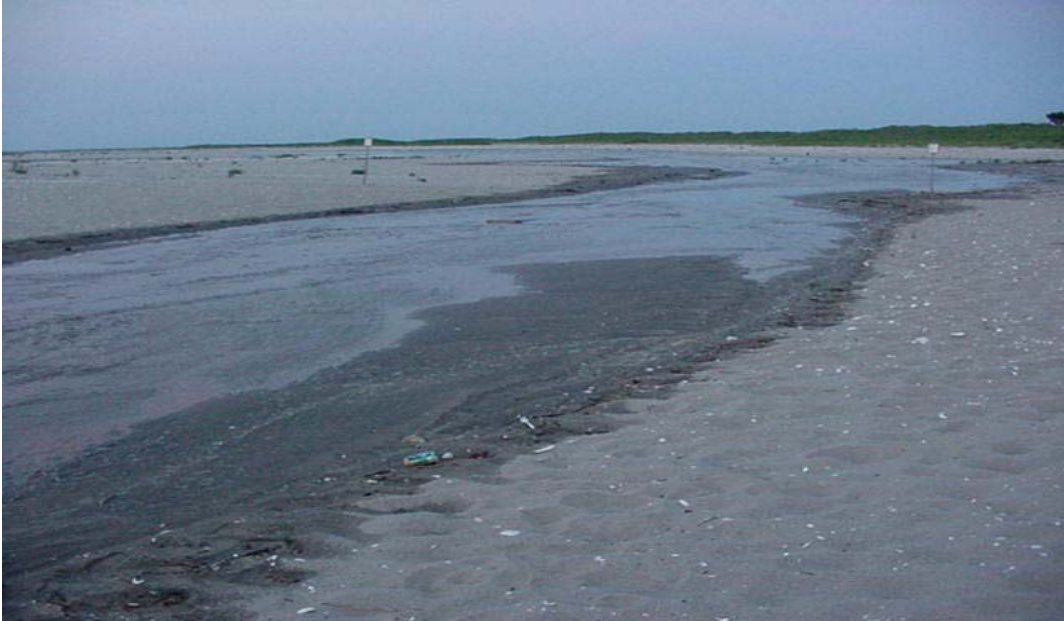
**GRAPHIC 10 Tidal maintenance of ephemeral pools on North and Coast Guard Beaches, 7/19/01, K. Terwilliger.**

**North Beach Ephemeral Pools At High Tide**  
(signs = protected area boundary with tidal influx into ephemeral pool)
